PHASE I REPORT

ENVIRONMENTAL INSPECTION
OF THE TEN-ACRE PLOT
PART OF THE MARK TWAIN INDUSTRIAL PARK

ST. LOUIS, MISSOURI

Envirodyne Engineers, Inc.
12161 Lackland Road
St. Louis, Missouri 63146

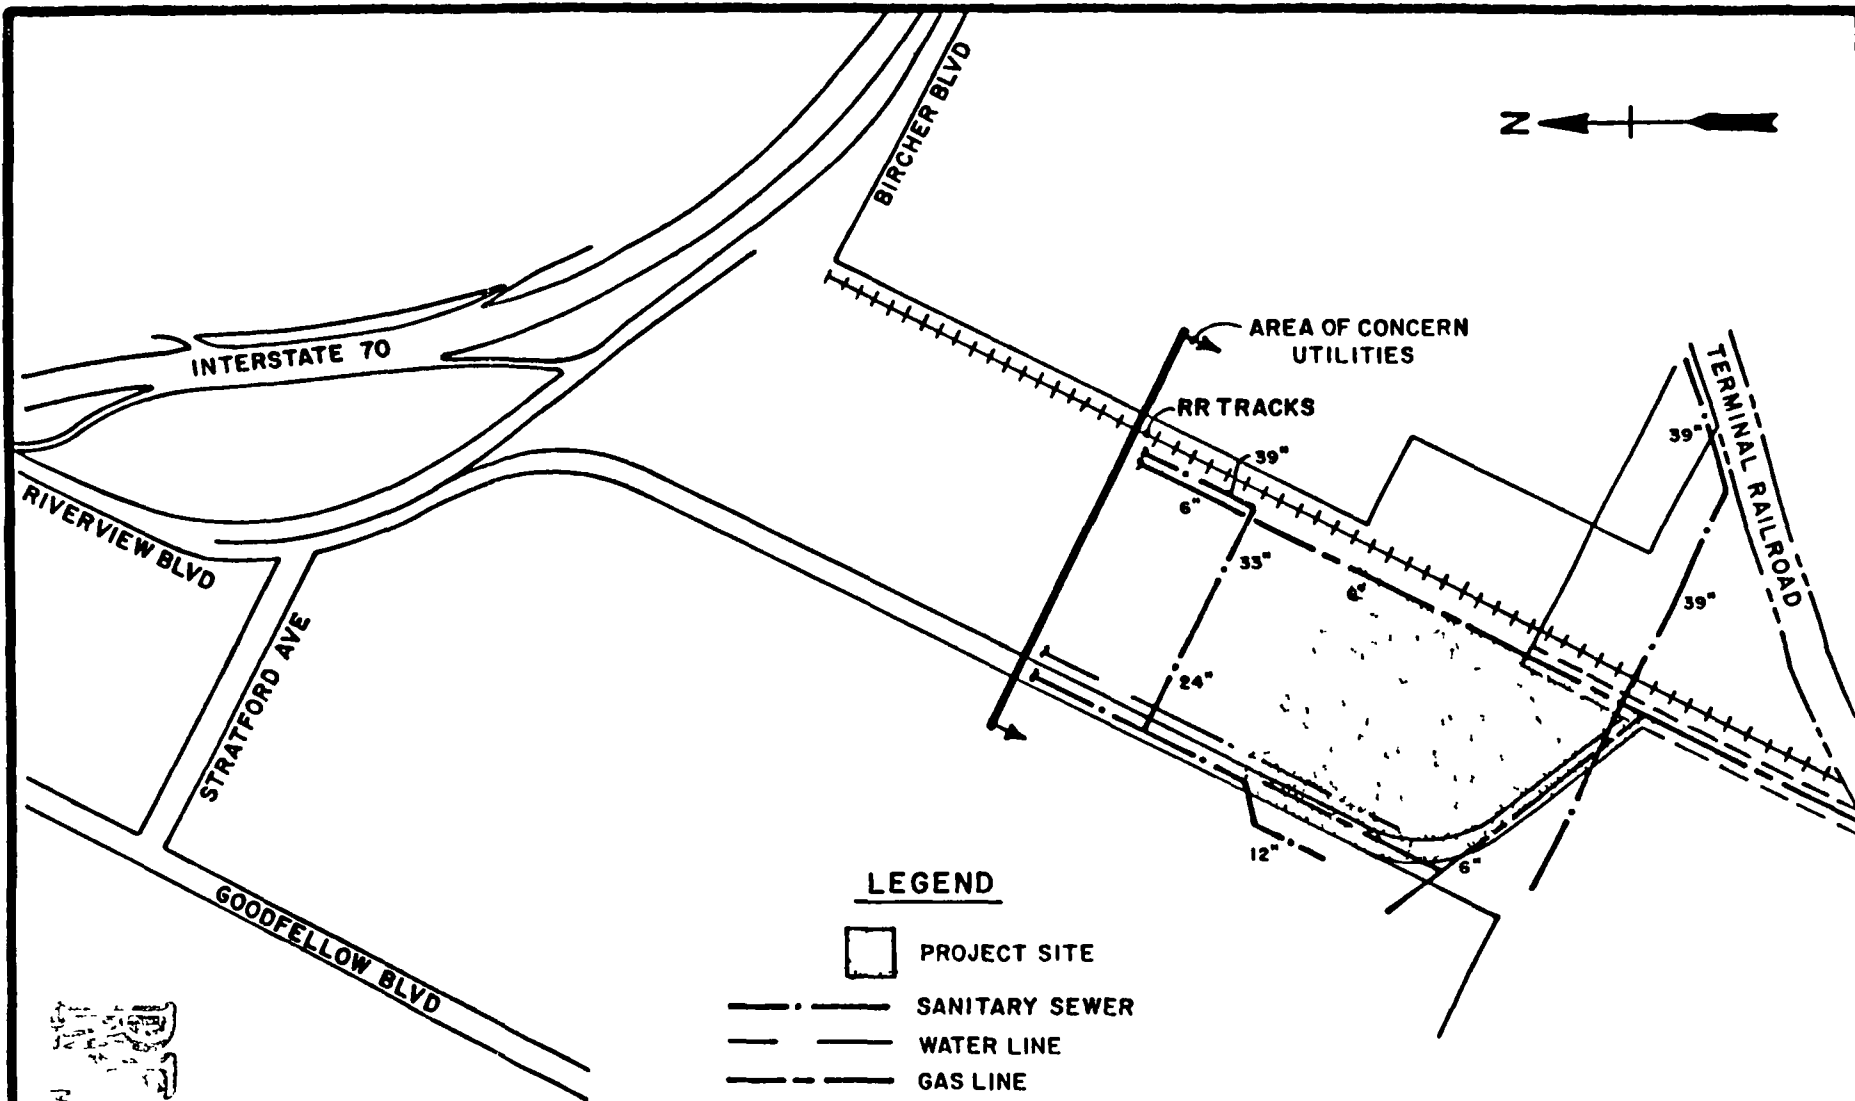
FIGURE 1

Current Site Conditions
-Existing Utilities

A visual on-site inspection was conducted on March 14, 1988. The 10-acre plot appeared to be graded and vegetated with grasses. Small concrete rubble piles were occasionally found along the eastern edge of the Mark Twain Industrial Park.

In Figure 1 current site conditions and existing utilities are presented.

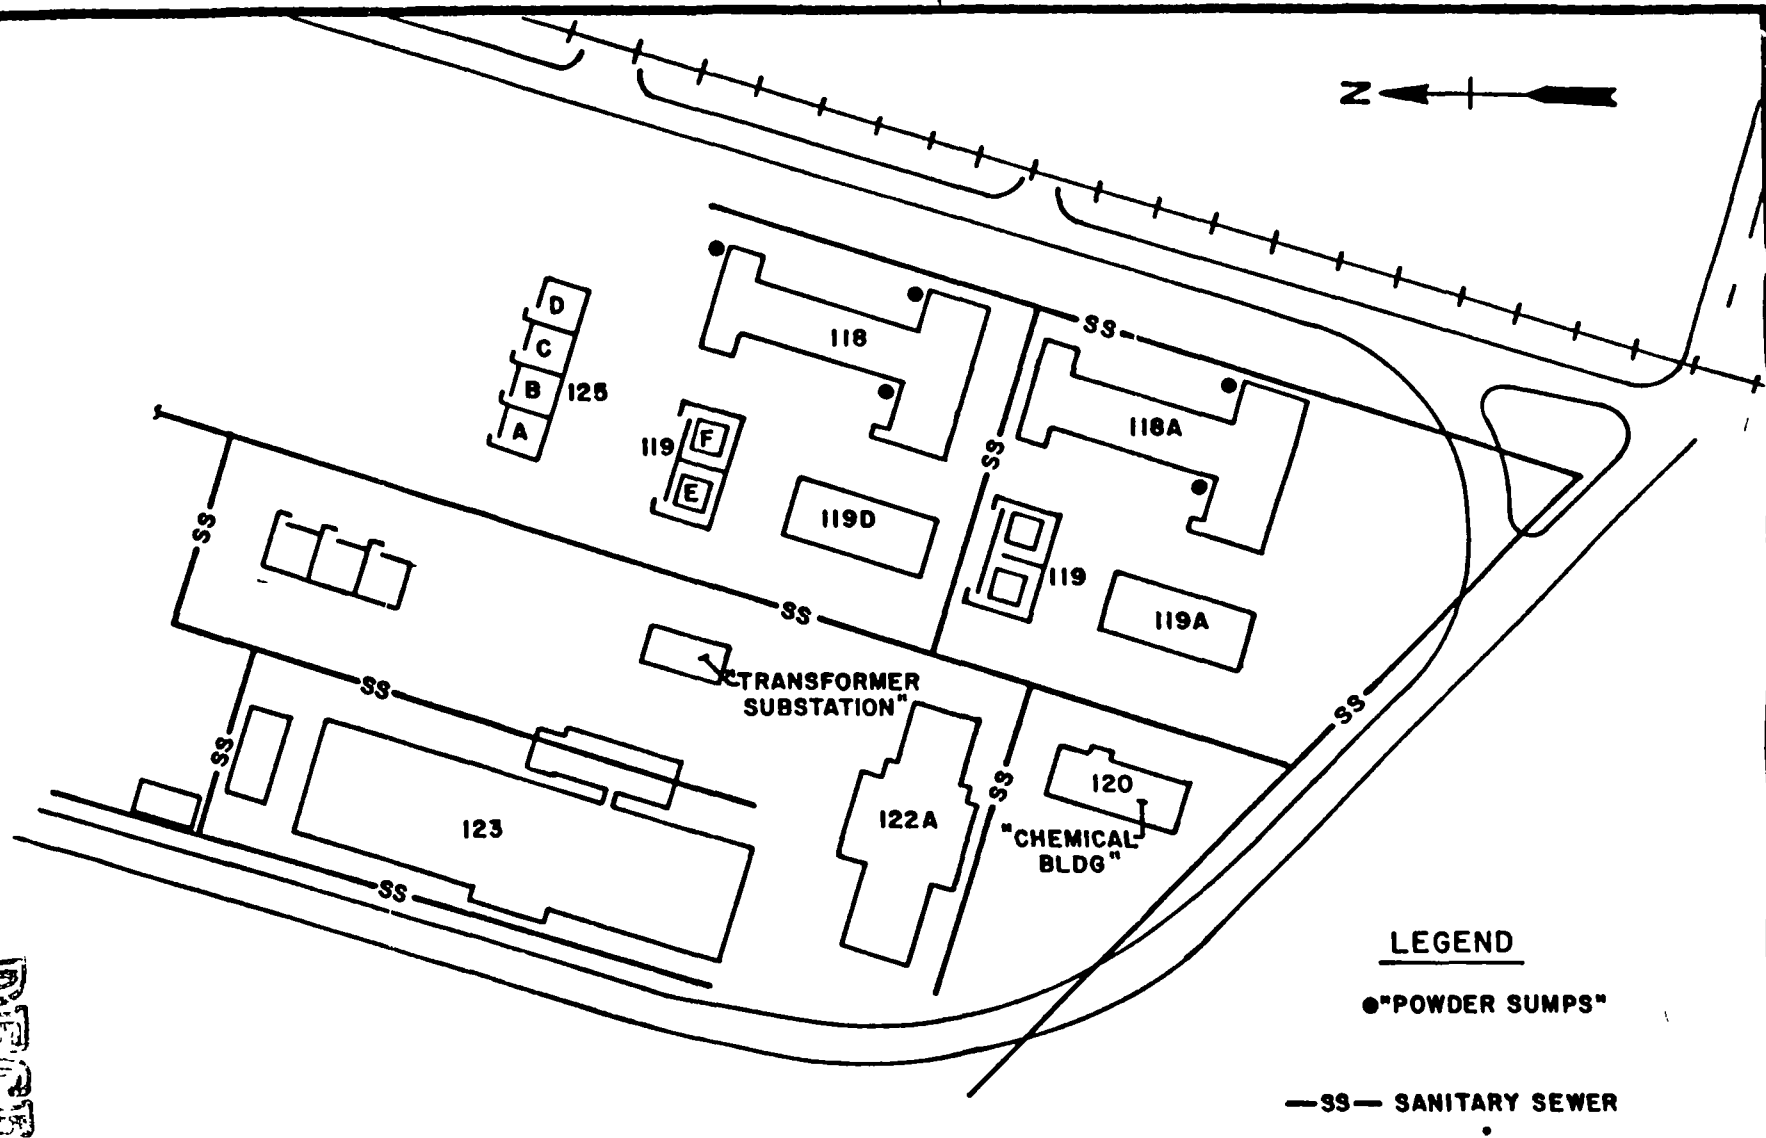
FIGURE 2
Previous Site Conditions-
10 Acre Area of Interest
Part of Mark Twain Industrial Park

Previous site conditions, prior to the 1980 demolition, are presented in Figure 2. Mr. Mullen had obtained a drawing of the site that included the buildings, bunkers (119), sewer locations and areas labeled "Transformer Substation," "Chemical Building," and "Powder Sumps."

Mr. Humphries explained that the "Powder Sumps" were concrete wells with concrete floors used to pump water from the floor of buildings storing gunpowder. The water and gunpowder residue was then pumped from the sumps and taken to a burning ground off-site. He did not know when the electrical transformers were removed from the substation or by whom.

- 7) The "powder sumps" previously contained gunpowder residue, again a possible source of contamination.
- 8) Since the entire Mark Twain Industrial Park has been regraded, there is the possibility that any contaminated soil has been spread out, pushed into pockets, pushed off-site, or remains near the source. The possibility exists that contaminants from other areas of the Industrial Park were spread onto the 10-acre plot during regrading. However, any "neighboring" contaminants would most likely be the same as those suspected on the 10-acre plot due to the history and previous operations of the Industrial Park.

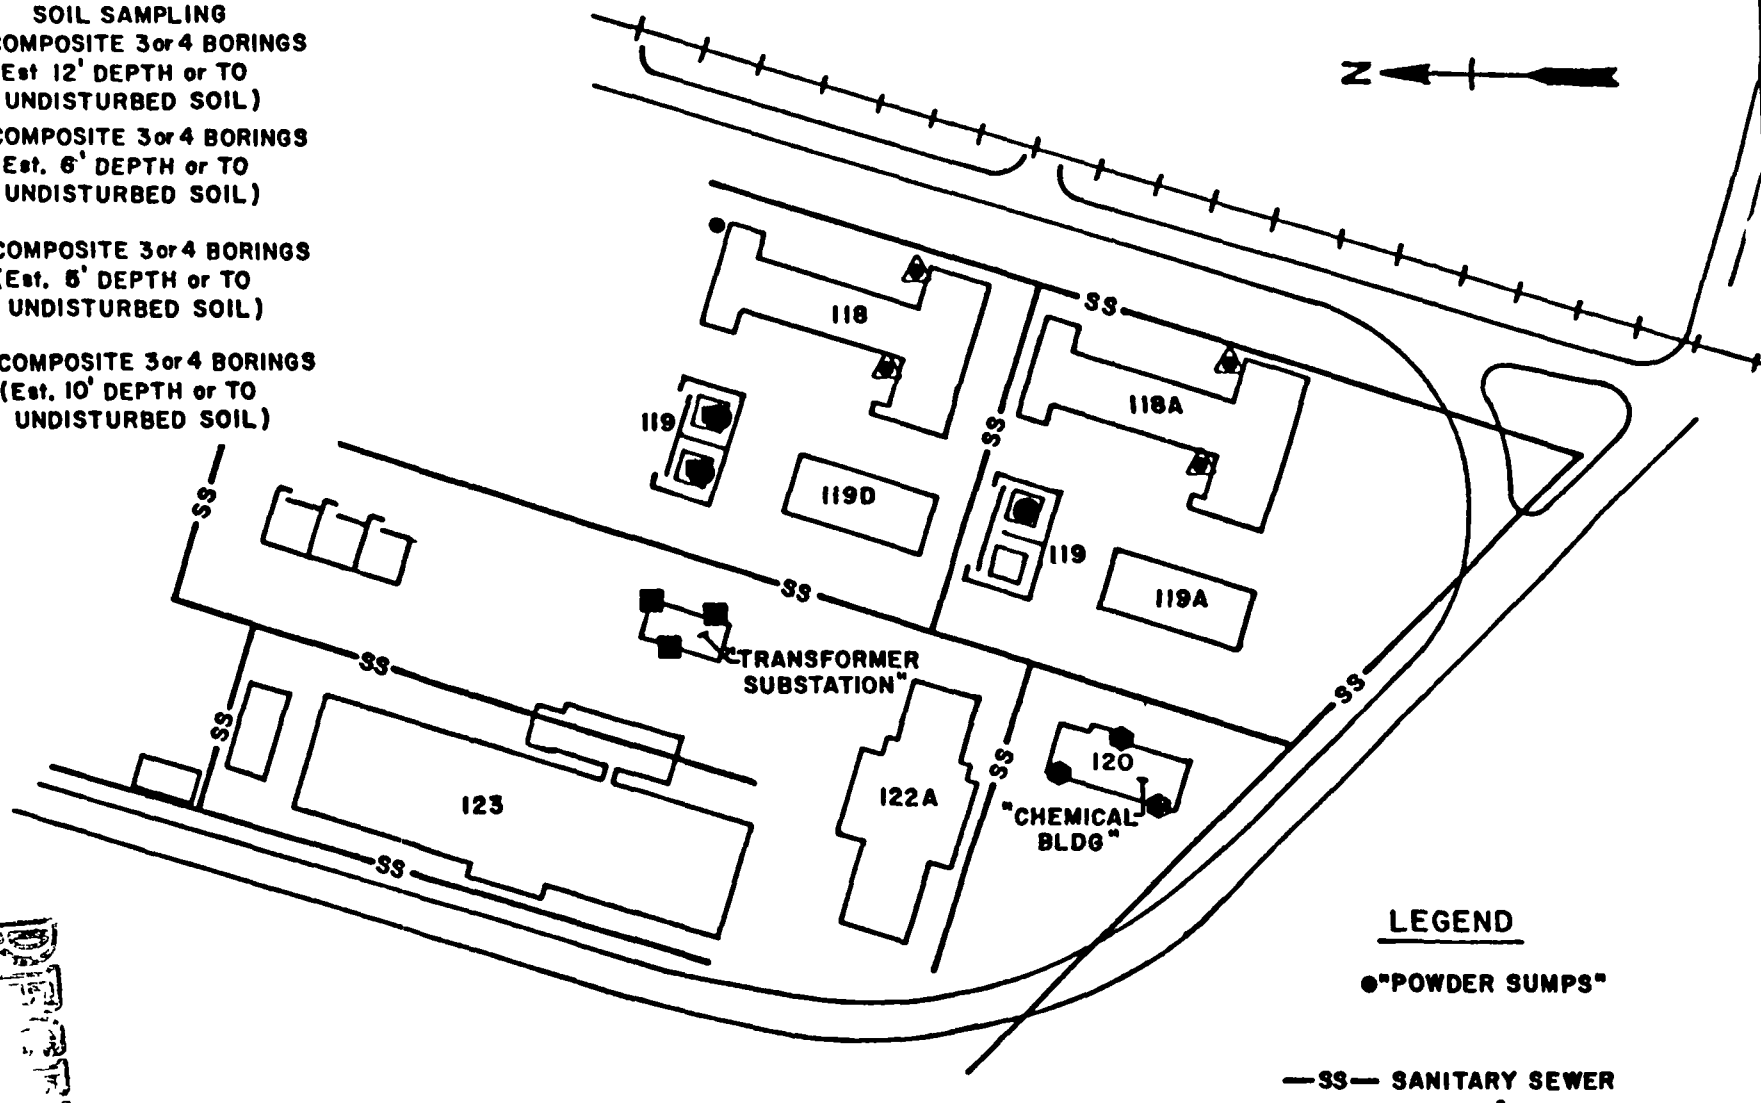
FIGURE 3

Proposed Sampling Locations
Previous Site Conditions

- 1) It is recommended that soil samples be taken around the "transformer substation" area (Figure 3) and analyzed for PCB's. If the soil is undisturbed (natural soil horizons), a composite of three to four five-foot borings would comprise one PCB sample. PCB's are not very soluble in water, so contamination would be expected to remain relatively close to the ground surface. If the soil is disturbed (fill/rubble), it is recommended that two samples be collected. One composite from three to four borings or disturbed soil and one composite from three to four borings of the underlying undisturbed soil.

- 2) It is recommended that a soil composite of three to four borings around the "chemical building" be collected and analyzed for barium, due to its toxicity. EEI does not see a need to analyze for Mg, since this metal is commonly found in the soil or for strontium due to its low toxicity. Previously mentioned in EEI's proposal were compounds found at other similar ordnance works, such as volatile organic compounds, lead, chromium, and mercury. These compounds were associated mainly with manufacturing or sewer disposal which is not a concern of this 10-acre plot and therefore not recommended analyses.

- 3) A soil composite of 3-4 borings near the bunkers is recommended. This soil would be analyzed for total nitroaromatics, nitrocellulose, and total nitrates. The results of the nitrocellulose analysis, would include the presence of all nitrates. Therefore the total nitrates result would be subtracted, giving a truer value of nitrocellulose.

If the soil is either undisturbed or disturbed, one composite would be collected from approximately a 12-foot depth. It is not necessary to go beyond 12-feet since this is where the bunker floor was said to be located. However, if the soil is disturbed and undisturbed soil is encountered before 12 feet, two samples will be collected, one from each layer.

- 4) It is recommended that a soil composite of 3-6 borings be taken around the "powder sumps", which were said to be located near gunpowder storage buildings. This soil would be analyzed for total nitroaromatics, nitrocellulose, and total nitrates.

If the soil is undisturbed, one composite would be taken from approximately a 6-foot depth. Again, if the soil is disturbed, one sample would be collected from the disturbed soil and one from the underlying undisturbed soil.
